# Dublin Port Company

## 2016 Maintenance Dredging Campaign

### Non Technical Summary

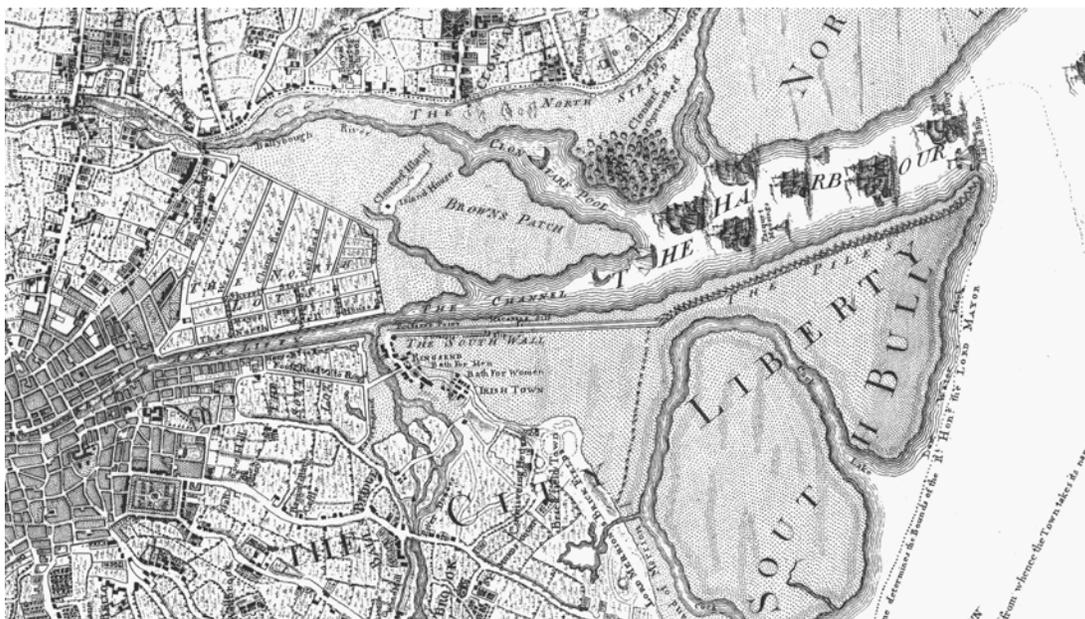
18th Century Map of Dublin (ca 1760) showing the extensive sand banks at the harbour entrance

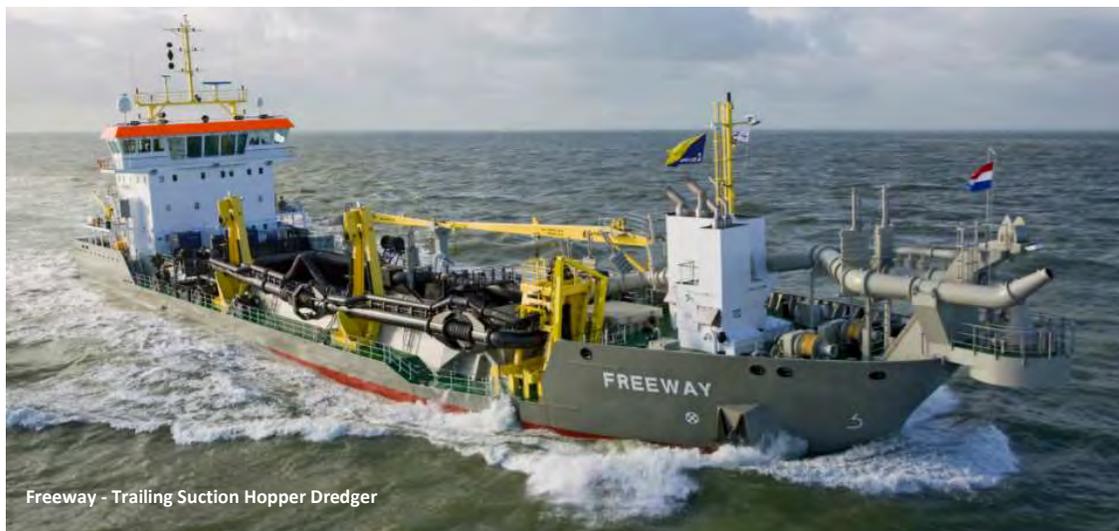
Boskalis, a leading international marine dredging company, was procured to carry out the necessary dredging operations. The principal method used was *'trailer suction hopper dredging'*. Trailing suction hopper dredgers are equipped with one or two trailing suction heads. When the ship reaches the location requiring dredging, they reduce speed and lower the suction heads to the seabed. The trailing suction head moves slowly over the bed, collecting the sand/silt in a similar way to a giant vacuum Hoover. The water and material mix is then pumped up the arm of the suction head to the ship where it is stored in the hopper. Once full, the dredger retracts its suction head and begins to sail slowly to the dumpsite.

When in position over the dumpsite, the ship slowly sails in the desired direction as doors in the underside of the vessel open up and the material is released from the hopper. This allows the operators to control accurately where the material is deposited.

This method of retaining all the sediment and dirty water in the dredger helped to limit the amount of sediment disturbed, reducing the amount of sediment that ended up suspended in the water and subsequently, the turbidity (murkiness) of the water. Dumping at the spoil grounds takes place through doors in the bottom of the hull and it takes about 10 minutes to release a load.

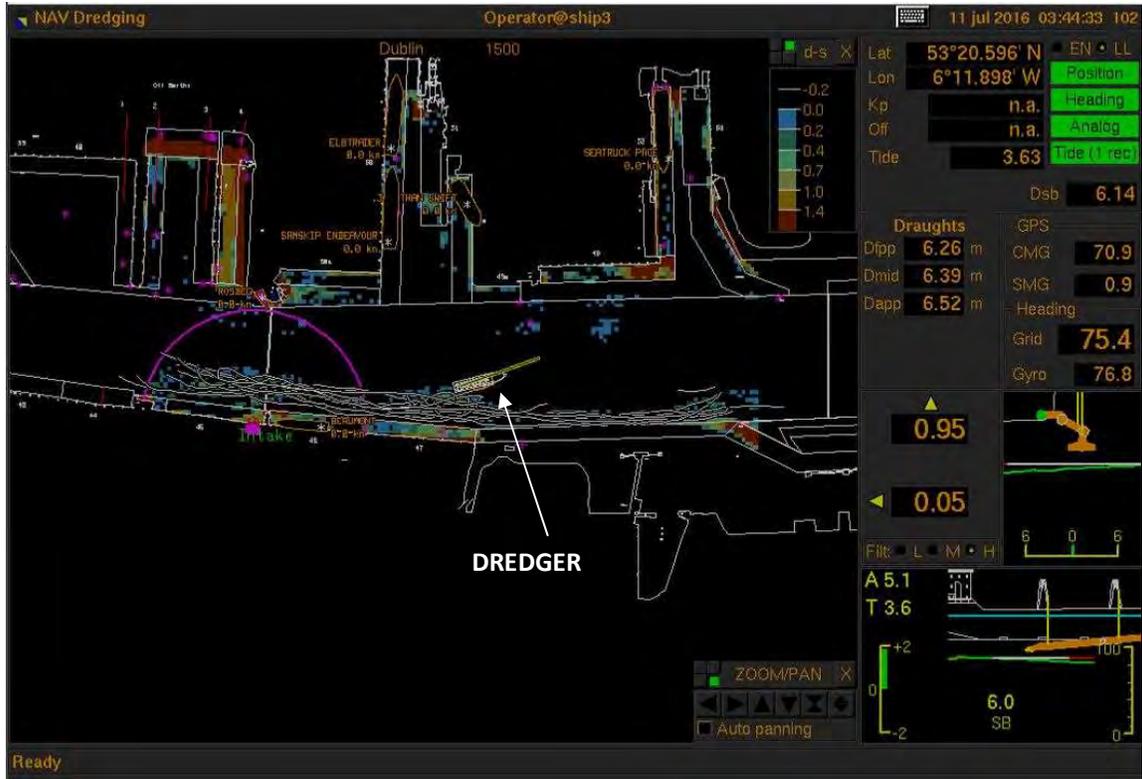
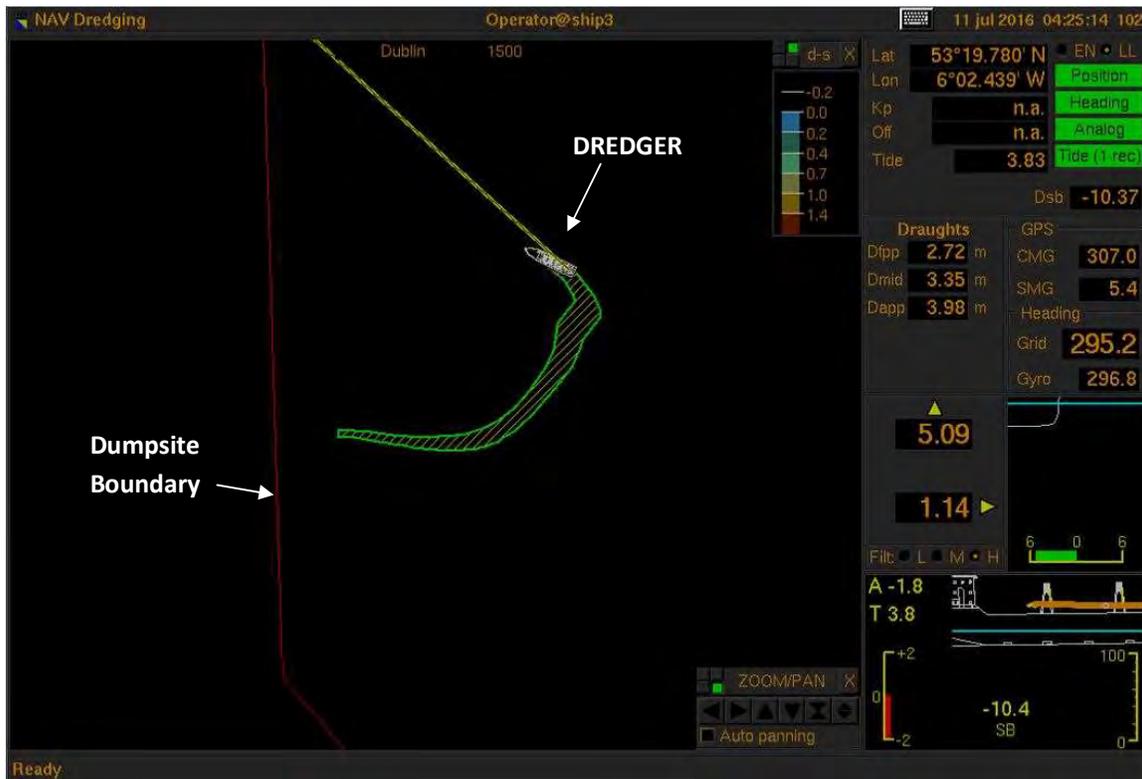
The entire dredging campaign lasted for a period of only 42 days. Dredging operations started on the 20th June 2016, and were completed by 31st July 2016. Throughout this period the dredger maintained a detailed record of all its activities including the locations at which it operated. These records allowed comparisons to be made with results of the monitoring programme to assess any potential environmental impacts caused by the dredging and dumping operations. The charts below are examples of the dredger location and activity records. The first chart shows the dredger as it is

leaving for the dump site after dredging along the South Bank Quay. Each dredge track is shown by the irregular white lines running parallel to the quay walls. In the second chart the hatched area shows precisely where this load was dumped at the spoil site.

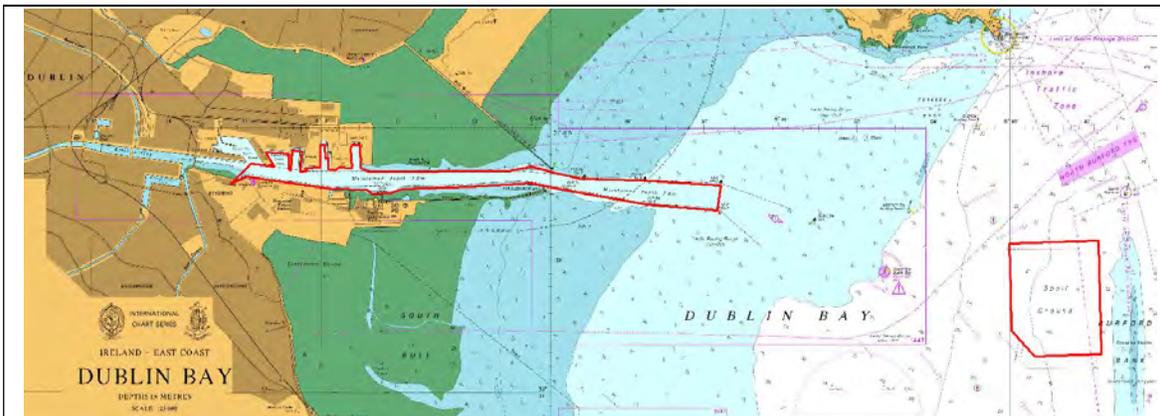
Areas dredged in the 2016 campaign and the offshore spoil site are outlined by the heavy red line.

The permitted areas to be included in the dredging campaign are set out in a Foreshore Licence issued by the Department of Environment, Community and Local Government (AKC/2016/00262) and the Dumping at Sea permit issued by the EPA (S0004-01). These allow for the removal of dredge material from the navigational channel and berths of Dublin Port and for the dumping of the dredge material at the approved Spoil Ground near Burford Bank off the coast of Dublin. The Spoil Ground is marked on the Dublin Bay Admiralty Chart (No. 1415). It is also referred to as the 'dumpsite' in this report.

DPC determined that the actual area that needed dredging in 2016 was less than that allowed for in the Dumping at Sea permit. The area from East Link Bridge to Ocean Pier (identified as North Quay Extension - B006, and River Area A - B007 in the Permit) did not require dredging and was excluded from the 2016 campaign.

The spoil dumpsite has been used by Dublin Port and a number of other permit holders since 1996. The site lies just west of the Burford Bank and is about 7km from the Poolbeg Lighthouse at the entrance to Dublin Port. The dumpsite is roughly 1¼ kilometres from east to west and about 1½ kilometres from north to south. It has an average depth of 20 metres.

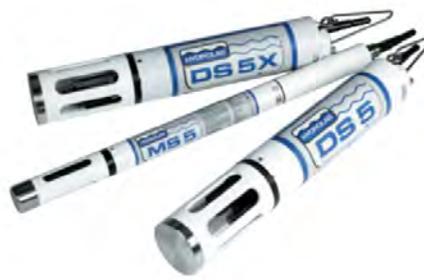
One of the main concerns expressed about water quality was that dredging and dumping might lead to large amounts of sediment being widely dispersed in the water. This could lead to murky water where visibility might be greatly reduced. To have information on the amount of sediment being suspended in the water DPC set up monitoring stations in the port and

outer Bay. Sensors at these stations measured turbidity every 15 minutes and relayed the data back onshore. This gave real-time information about what was happening during the dredging and dumping operations.

Monitoring equipment was set up at East Link Bridge, Poolbeg Sludge Jetty and North Bank Light in the harbour area to measure turbidity during the dredging campaign. Measurements were usually made every 15 minutes. However, it is always difficult to keep sensors in good condition in the marine environment and some problems occurred with fouling by dirt and algal growth at East Link during the monitoring period. Regular visits were made to clean and calibrate the instruments to minimise the affect this had on the results.

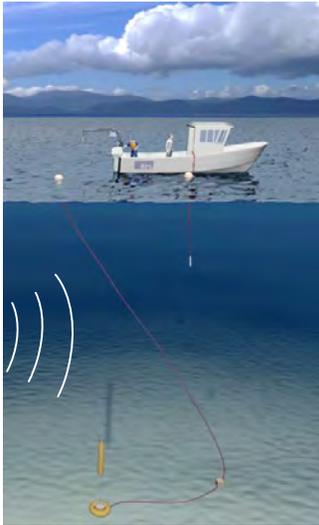
Measurements were made on July 14th at three locations in the Liffey channel near the North Bank Lighthouse and at one location in the spoil grounds. The dredger was removing silty sand and dumping this dredge material at the offshore spoil ground during the noise measurements.

On one of the measuring occasions in the channel, it was impossible to distinguish the dredger noise from the noise of other passing ships. On the other two occasions, one when the hydrophone was 213m from the dredger and the other when it was 268m away, the sound levels were below the levels that cause any disturbance for the sensitive harbour porpoise.

The measurements at the dumpsite were made only 90m away from the operating dredger. At this distance the noise was marginally above the disturbance level for porpoises, but it was still below the disturbance level for Marine Mammals in general. It is important to note, as explained below, that work would not be allowed to start if a porpoise was this close to the dredger in the first instance.

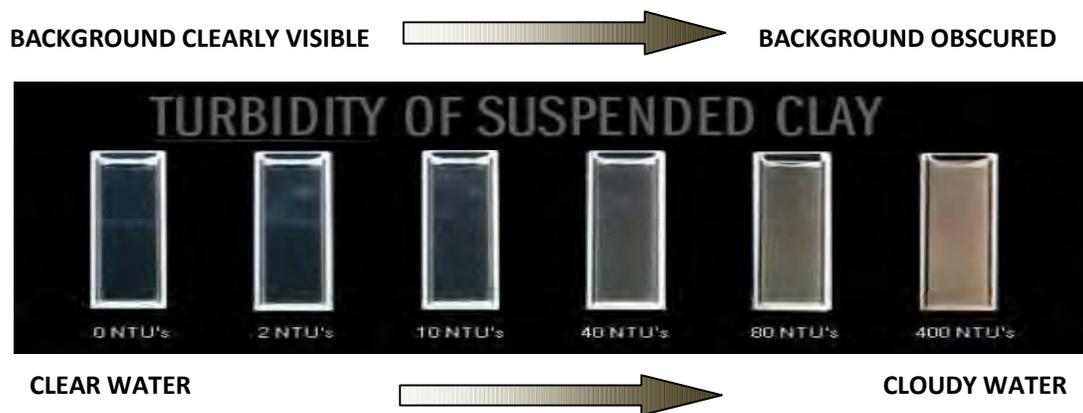
Turbidity is measured in NTU, which is basically a measure of the amount of light scattered by the particles in suspension when a light is shone through the water. The following examples help to give some sense of what turbidity measurements look like or mean. Irish regulations suggest that drinking water production plants should try to achieve a value of 1 NTU in drinking water leaving the plants. However, about one third to one half of plants are presently producing drinking water with turbidity greater than 1 NTU. The picture below shows what water at different turbidity levels looks like. Water with a turbidity value below 4 NTU is visibly clear to the human eye and is generally very acceptable aesthetically.

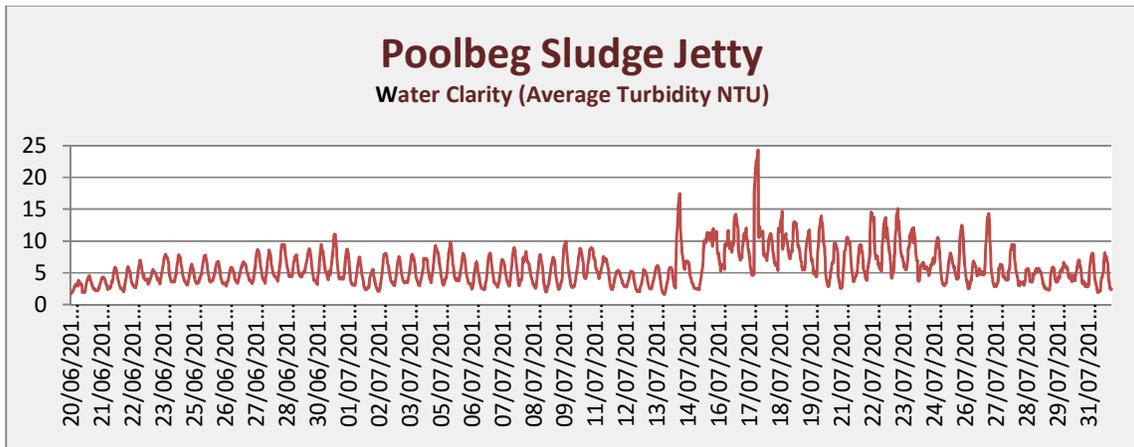
This graph is an example to show how turbidity has fluctuated at Poolbeg Sludge Jetty during the maintenance dredging campaign. It shows the average turbidity every four hours from the 20th June until the 31st July. The regular up and down movements of the red turbidity line reflect tidal changes and how they can influence turbidity at this location.

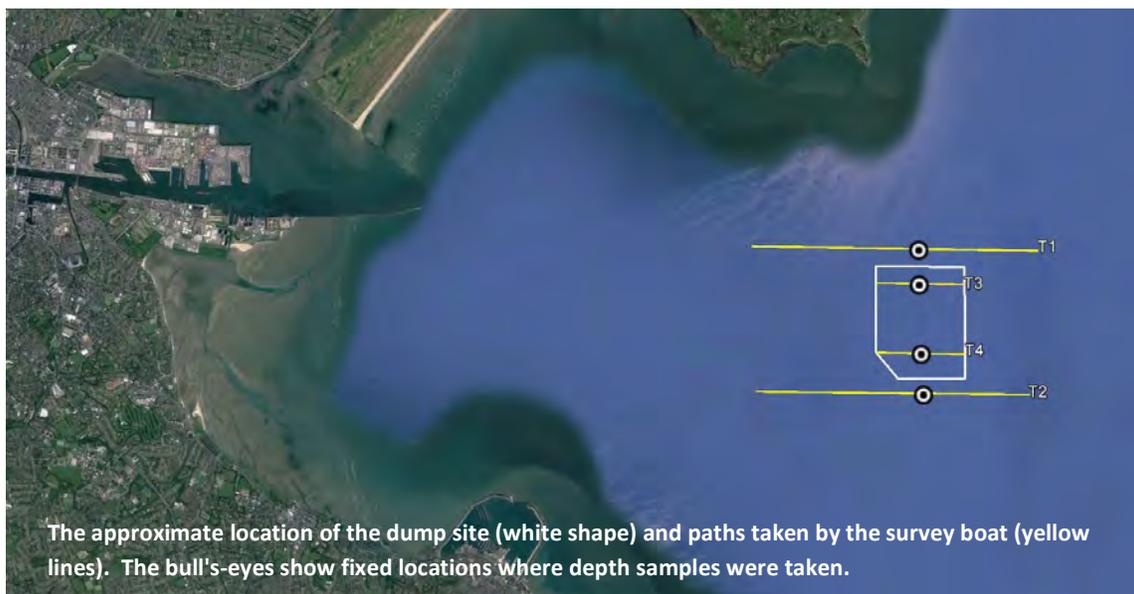
During the maintenance dredging campaign, turbidity was also measured in the outer bay area using monitoring equipment fixed to the Dublin Bay buoy and in the vicinity of the dumpsite using a boat. The survey boat sailed along 4 different fixed paths (transects) while taking measurements every few seconds near the surface of the water. These transects were located inside and outside the dump site, to the north and south. The positions of the Dublin Bay buoy, the transects and the dump site are shown on the map below.

All of these measurements (the transects, at the buoy, at different depths and tidal stages), were carried out to detect any plumes of sediment spreading from within the dump site when dredge spoil was released. The results from each approach are discussed next.

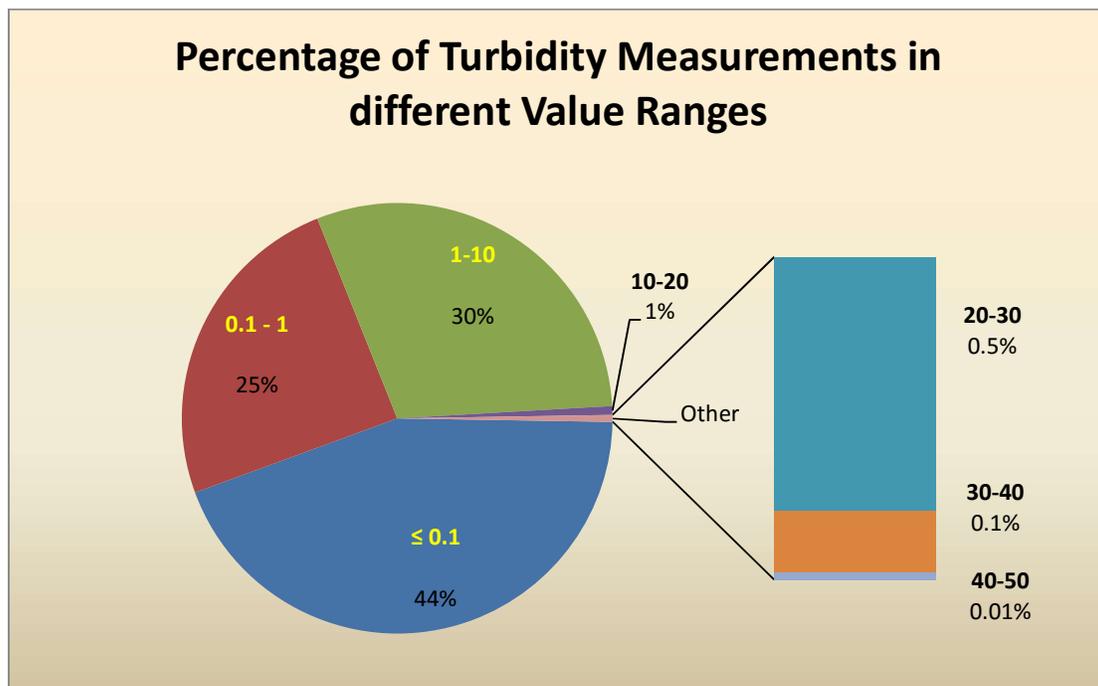
The pie chart below shows how the quarter of a million turbidity measurements were distributed ranging from very low values of less than 1, to values over 50. The chart shows that 99% of the measurements (i.e. the three biggest slices of the pie) were 10 NTU or less.

These results demonstrate that turbidity was low and water clarity was good during the dredging campaign. In fact turbidity greater than 30 was only measured during monitoring of four of all the transects taken; one of these on the 23<sup>rd</sup> July and the other three on the 25<sup>th</sup> July. On both the days the transects were being sampled the sea was calm and there were only light breezes. When the data is examined, there is no connection obvious between periods when dumping occurred and water clarity. Indeed the highest turbidity values on these days were recorded 1 to 2 hours after the dredger had left the dump site. As mentioned earlier, turbidity can also result from algal growth (small plant cells suspended in the water) and the calm conditions occurring during this interval are ideal for such algal blooms to occur.

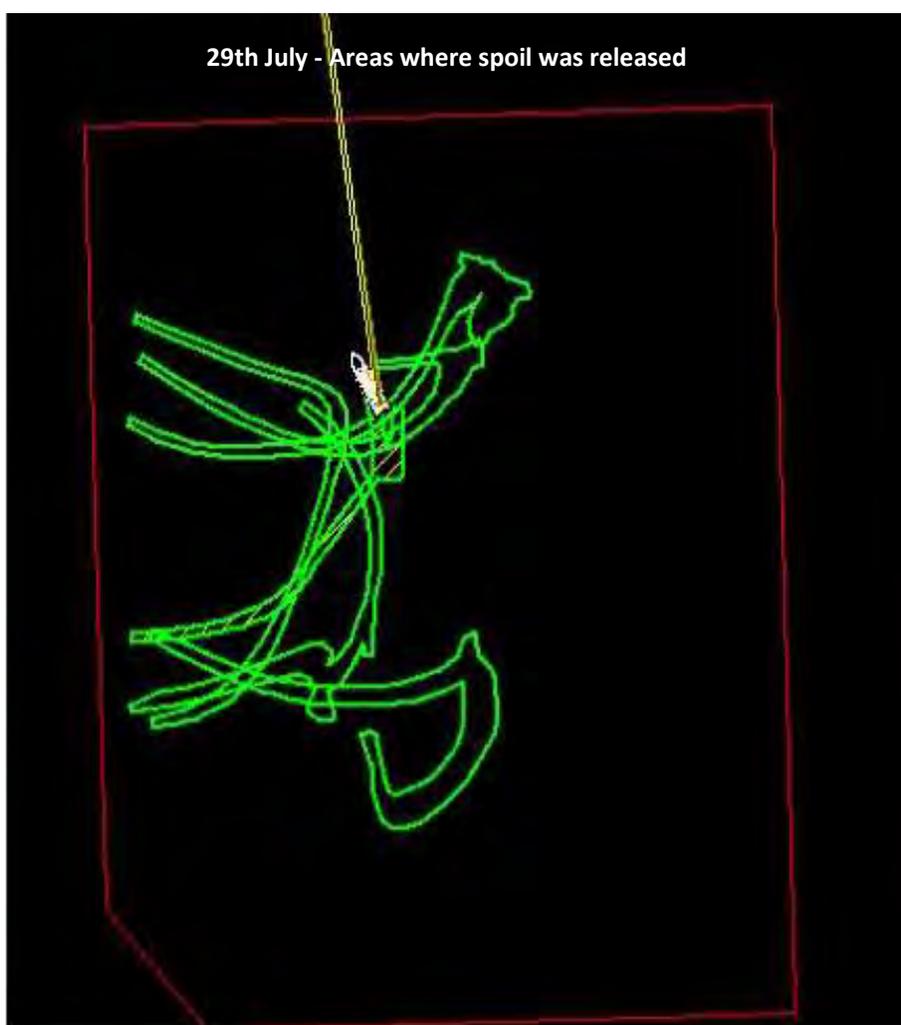
In addition to the transects, the survey boat measured turbidity during a full tidal cycle on the 29th July at the four fixed locations shown by the bull's-eyes on the map. Turbidity was measured near the surface, in mid water and near the sea bed roughly every hour. The dredger made nine trips to the dump site on this day and released its loads near the centre of the dump site in the area between the two inner bull's-eye markers. These are about 1km apart, so dumping took place well within 500m of these sampling points. The precise locations where dredge spoil was released on the 29th July are shown by the paths marked in green on the chart below.

Once again the turbidity results indicate that water clarity was very good throughout the tidal cycle and at all water depths at the four fixed locations. The average turbidity was less than 1 NTU and the highest value recorded was 10.

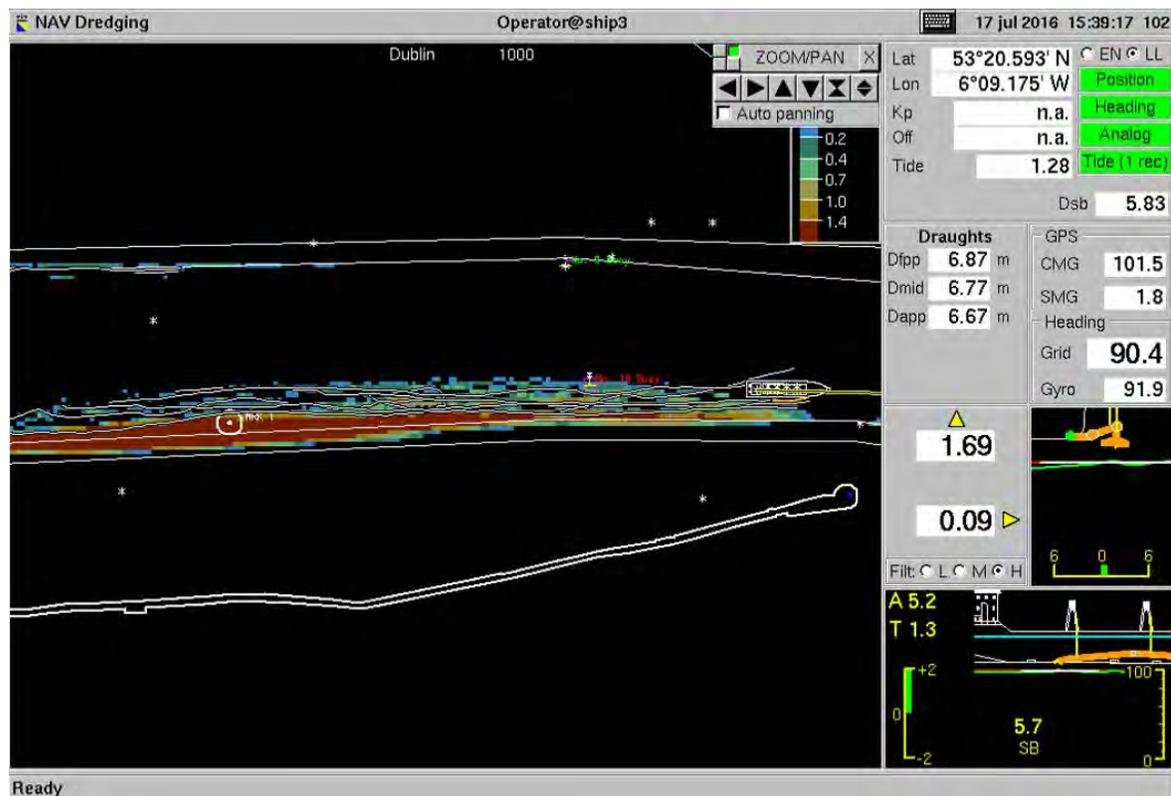
Dredger movements and operation were recorded in detail during the entire period of the campaign. The chart below for the run we are describing shows that the dredger loaded in the inner channel near the mouth of the harbour at the Poolbeg Lighthouse. Loading took place during an ebb tide and finished at 15.40h, approximately 50 minutes before the low tide.

The trip to the dumpsite takes about 30 minutes. The Freeway began dumping at 16.06h and the load was completely released by 16.23h, i.e. over a period of about 17 minutes. This was just before a low tide of 1.14m at 16.31h on the 17th July.

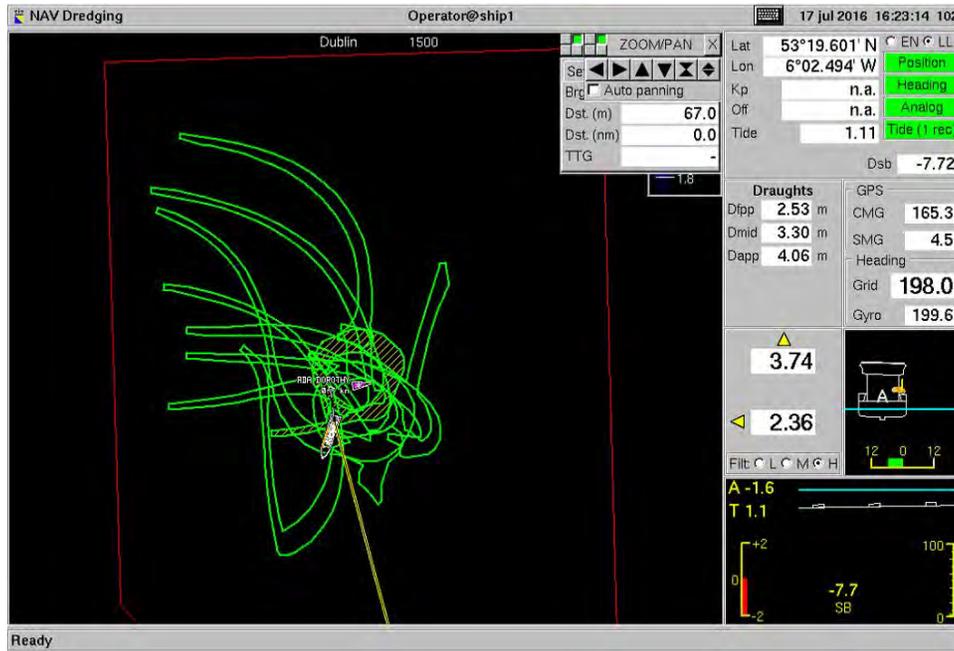
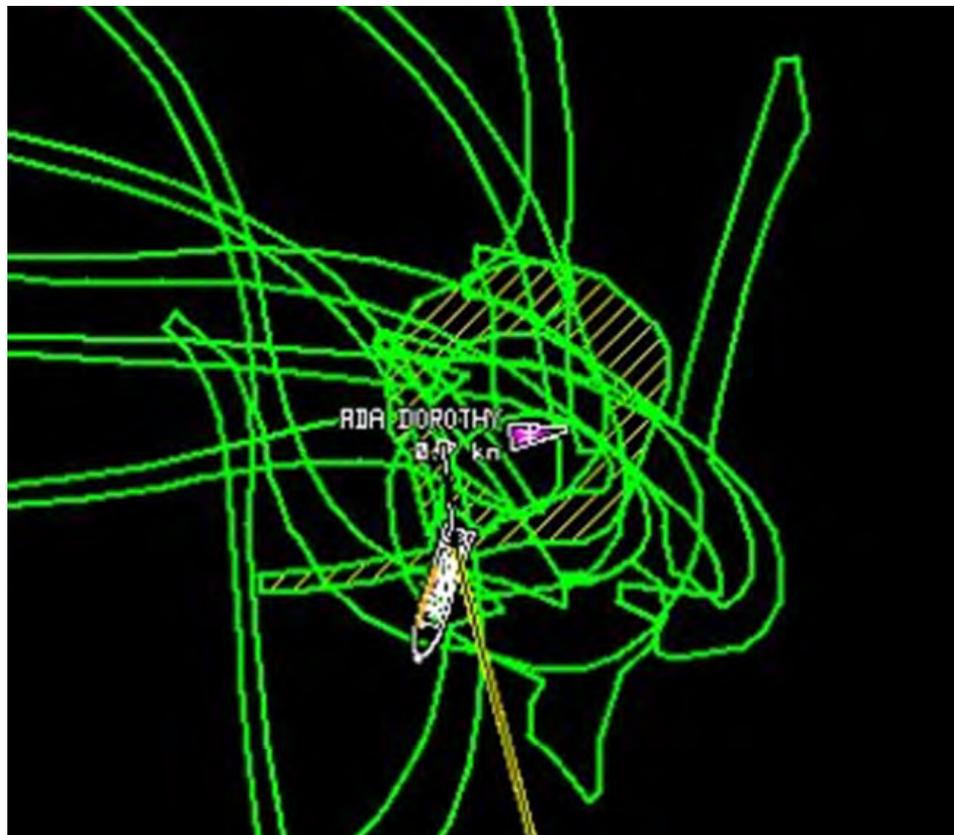
These next charts show where loads on the 17th July were dumped (the second chart is just an enlargement of the central area to help with clarity). The red lines that can be seen mark the boundary of the licensed dumpsite, and it is clear that all dumping takes place in the allowed area.

The Freeway's course during the dumping operation we are describing here is marked by the hatched green circular area. Other green lines show previous dumping runs. The tug ADA Dorothy carried the drone and was on site to start filming when the dredger arrived. Her position is marked on the chart at the centre of the dumping run. The ADA Dorothy remained anchored at that location throughout the period of filming and she provides a good reference point when looking at the photographs below.

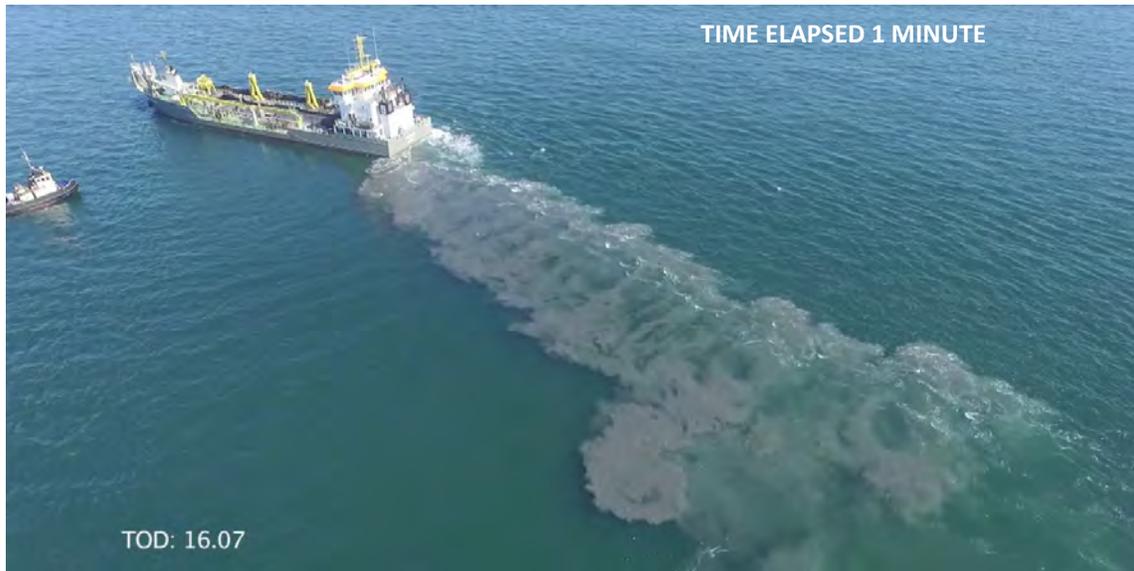
**1**

The Freeway arrives at the dumpsite, reduces speed and begins releasing her load. Most of the dredge spoil is released in the first few minutes. The ADA Dorothy is just visible on the left of the photograph.

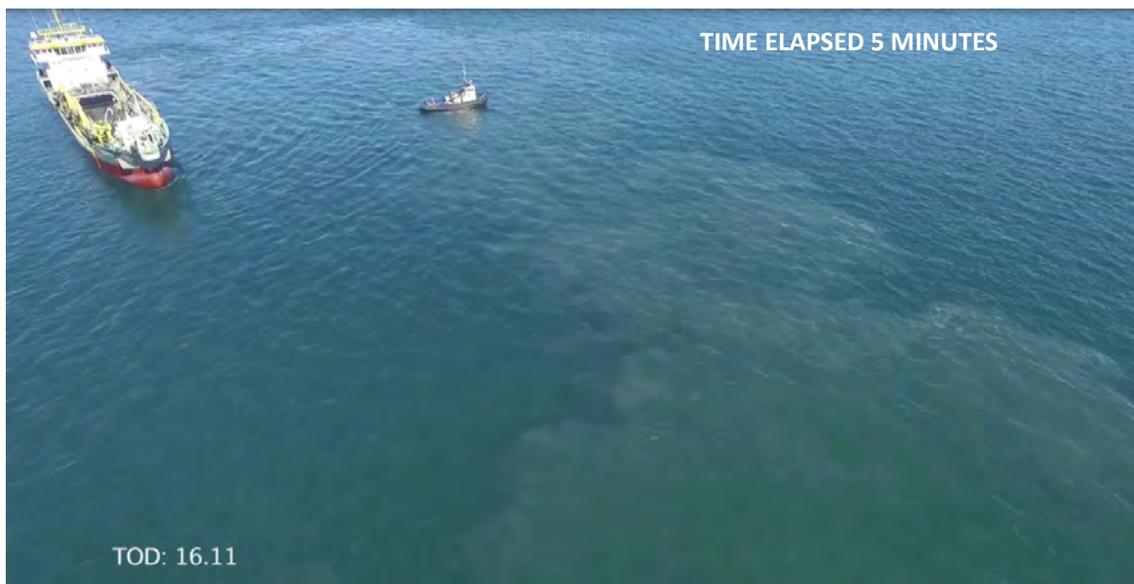
**2**

The plume of released sediment remains relatively concentrated along the release path and has already begun to settle below the surface. The dredger is circling and still releasing the remainder of its load.

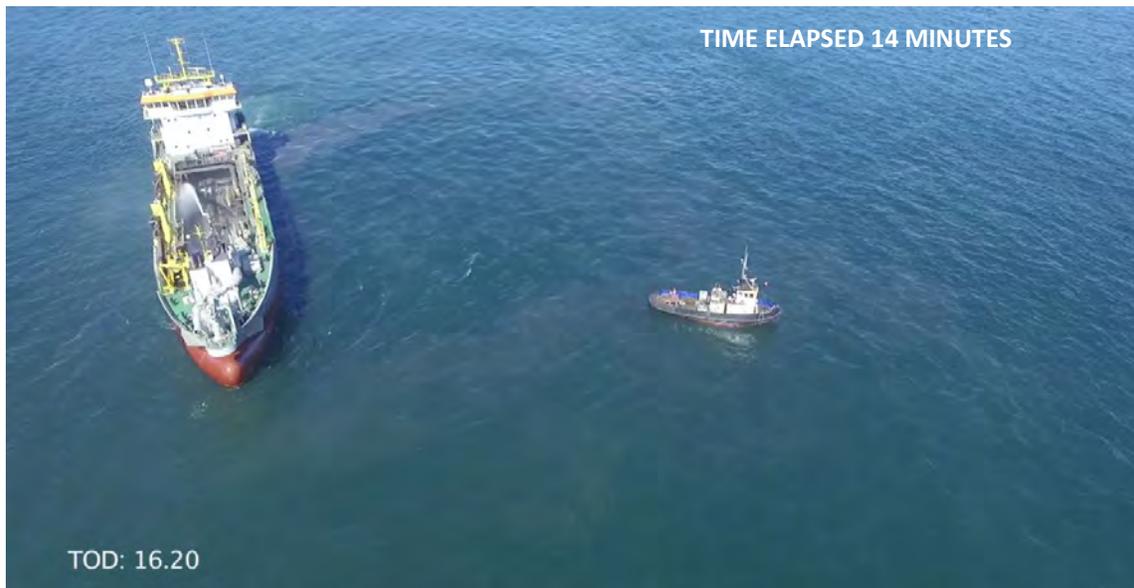
**3**

The dredger is now empty and hosing out her hold to clear remaining spoil before leaving the dump site. The hose jet is visible in mid ship. Even at this stage the sediment released in the first pass is no longer obvious. The run is complete in just 15 minutes and the dredger is returning to the Port. The ADA Dorothy remains on site to film with the drone.

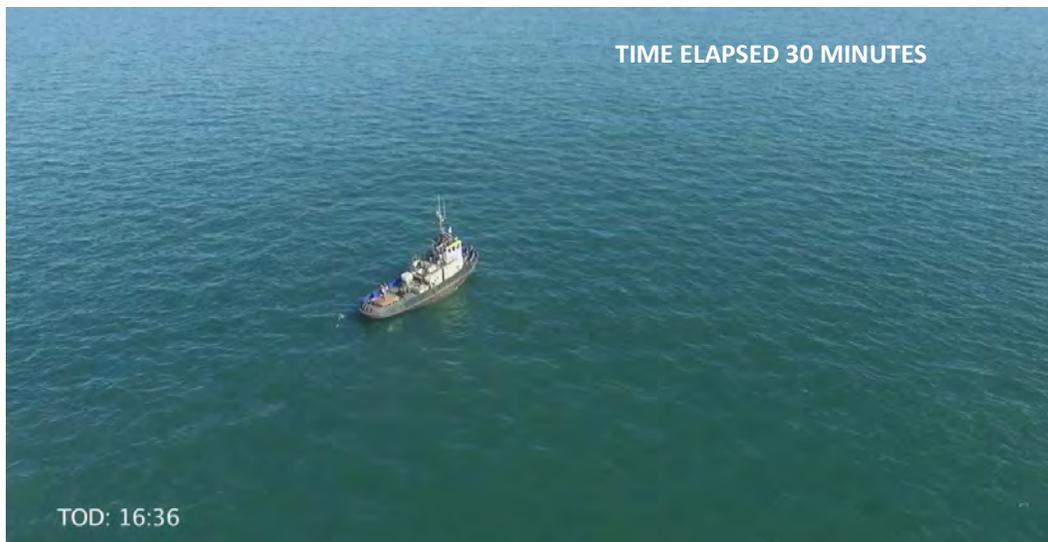
**4**

Within 15 minutes of the Freeway completing the release of spoil and leaving the site, the surface water at the dumpsite appears clear. So within half an hour of beginning operations there is no visible evidence of spoil dumping.

Footage filmed from an aerial drone shows that when dredged material is released at the dumpsite it is visible in the immediate vicinity of the dredger and along the dump path for a short period afterwards. The material tends to remain close to the point of release while settling below the surface. Dumping is completed in about 15 minutes and within a half hour of the beginning of operations the water appears clear at the surface and is aesthetically acceptable with no visible evidence of a silt plume.
