Dublin Port Company

Dumping at Sea Permit S0024-01

Annual Environmental Report 2017

DUBLIN PORT COMPANY
Dumping At Sea Permit S0024-01
Annual Environmental Report, 2017

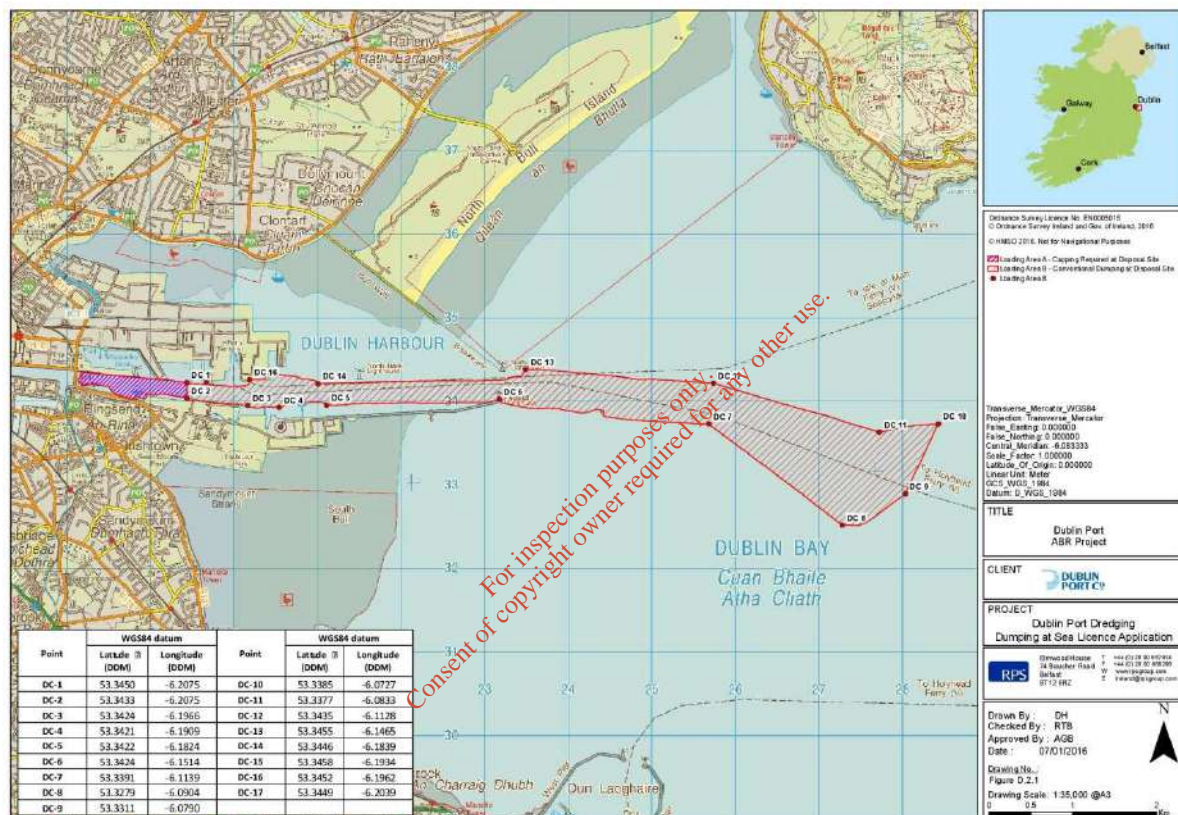
Figure 1.2 Permitted Loading Area (Area B)

Note: Loading and Dumping is not permitted within Area A, denoted in Figure 1.2, under Dumping at Sea Permit S0024-01. Area A contains pockets of Class 2 sediments (slightly contaminated).

The overall permitted loading area is presented in Figure 1.2. Loading for the period October 2017 – December 2017 was confined to a single block within Dublin Bay as shown on the following two drawings, presented in Appendix 2.2. A marine site investigation undertaken by Fugro in 2016 found the sediments within this block to be predominantly fine sand.

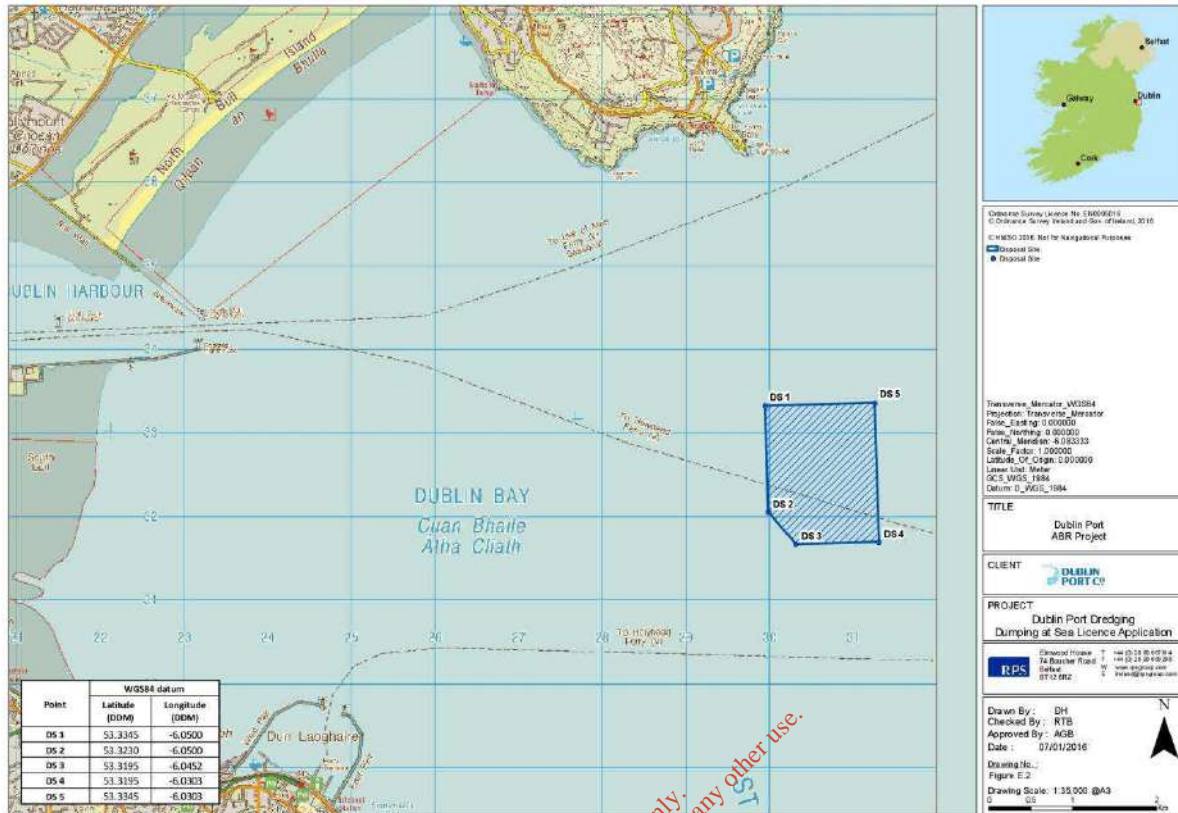
Figure 1.3 Dumpsite Location

DPC applied for and were granted a Dumping at Sea permit from the EPA. The permit register number is S0024-01 and was granted on 13th September 2016. This allows DPC to load dredged material and to dump the dredge material from Dublin Port within the licensed dumpsite located to the west of the Burford Bank at the entrance to Dublin Bay. The area in which loading is permitted to take place is shown in Figure 1.2, denoted as Area B. Chemical sediment testing of the material to be dredged from Area B has been shown to be suitable for disposal at sea. The location of the licenced dump site is shown in Figure 1.3.

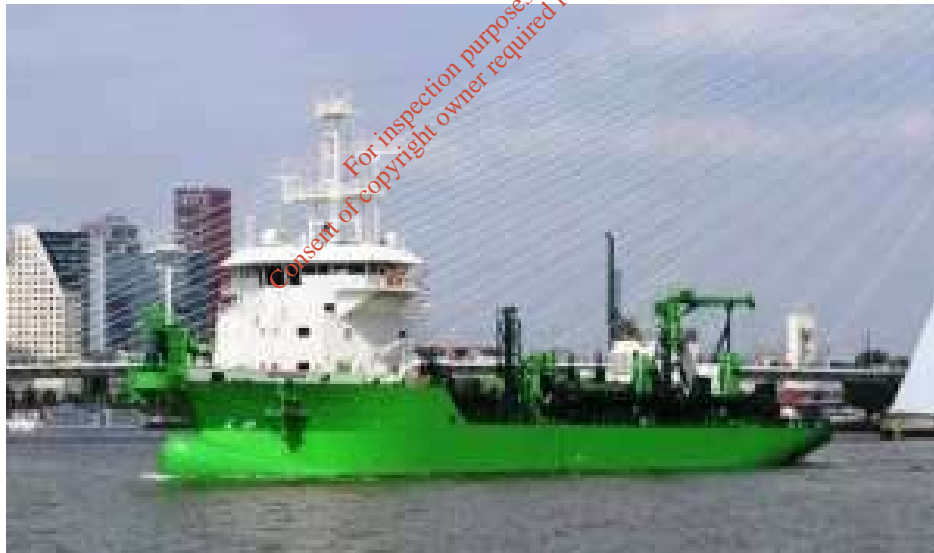
Figure 2.1 NewWaves Solution's Trailer Suction Hopper Dredger Minerva

The October 2017 dredging campaign was undertaken using NewWaves Solution's Trailer Suction Hopper Dredger (TSHD) *Minerva* which has a hopper capacity of 3,500 cubic metres. The Equipment sheet for the *Minerva* is presented in Appendix 2.1.

NewWaves Solution's Trailer Suction Hopper Dredgers are equipped with a trailing suction head. When the ship reaches the location requiring dredging, it reduces speed and lowers the suction head to the seabed. The trailing suction head moves slowly over the bed, collecting the sediments in a similar way to a giant vacuum Hoover. The water and material mix is then pumped up the arm of the suction head to the ship's hull (hopper). Once full, the dredger retracts its suction head and begins to sail slowly to the dump site.

When in position over the dump site, the ship slowly sails in the desired direction as doors in the underside of the vessel open up and the sediment is released from the hopper. This allows the operators to control accurately where the sediment is deposited.

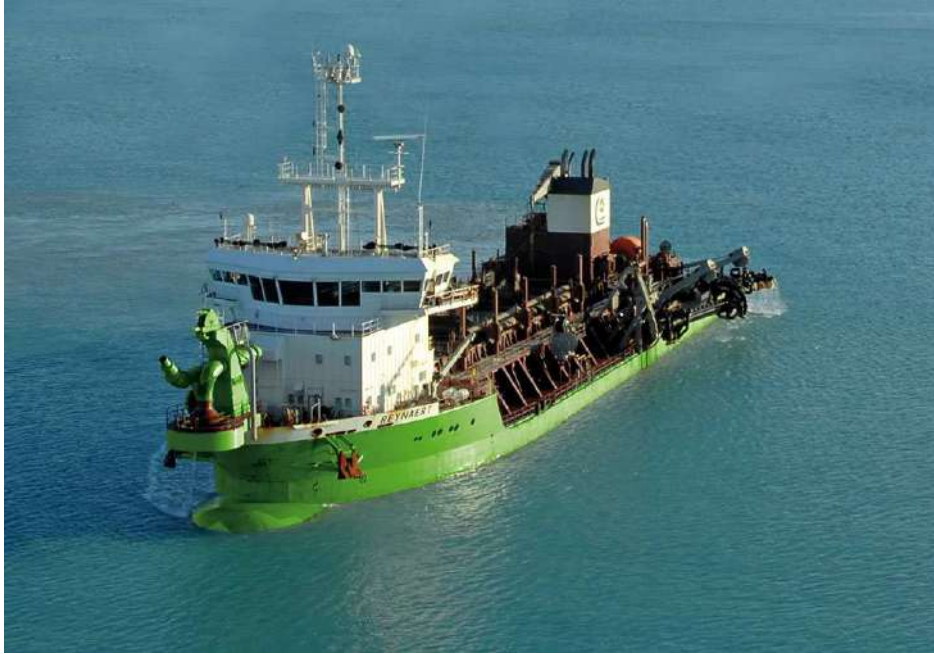
Figure 2.2 NewWaves Solution's Trailer Suction Hopper Dredger Reynaert

The *Minerva* was replaced by the *Reynaert*, a larger Trailer Suction Hopper Dredger which has a hopper capacity of 5,580 cubic metres, for the November 2017 and December 2017 dredging campaigns. The Equipment sheet for the *Reynaert* is also presented in Appendix 2.1.

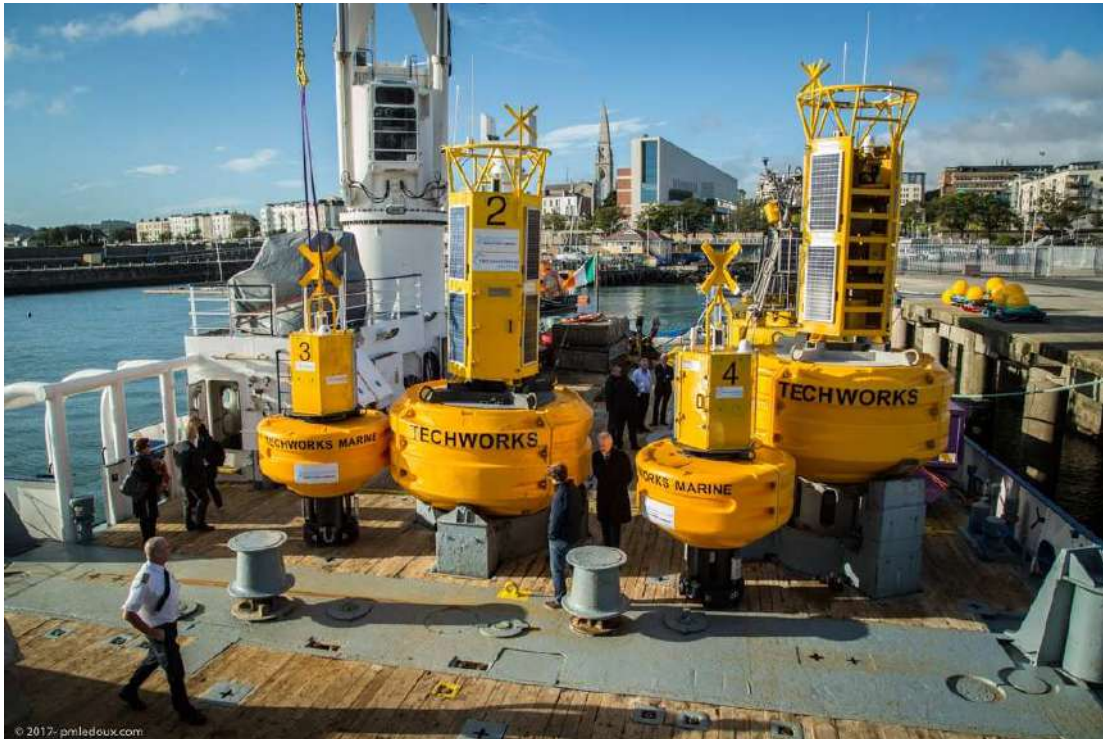
Turbidity is to be measured continuously at four monitoring locations at various depths (near-bottom, mid-column and near surface). Mobilis buoy hulls have been used to provide platforms for monitoring equipment at the required locations. Two buoy sizes have been deployed. A DB2000 buoy hull has been deployed at two sites where instrument power demands are lower. However, at two sites with additional instrumentation (ADCP, Wave Sensor and PAM systems) greater power demands have required the use of DB8000 buoy hulls to support additional solar panels. The buoys have two point moorings. The moorings on the DB8000 hulls are specialised silent moorings to facilitate acoustic recording on these platforms. Each buoy continuously records turbidity using three Seapoint turbidity sensors deployed in-line from the centre of the buoy hull.

Monitoring Buoys on board the ILV Granuaile for deployment in Dublin Bay

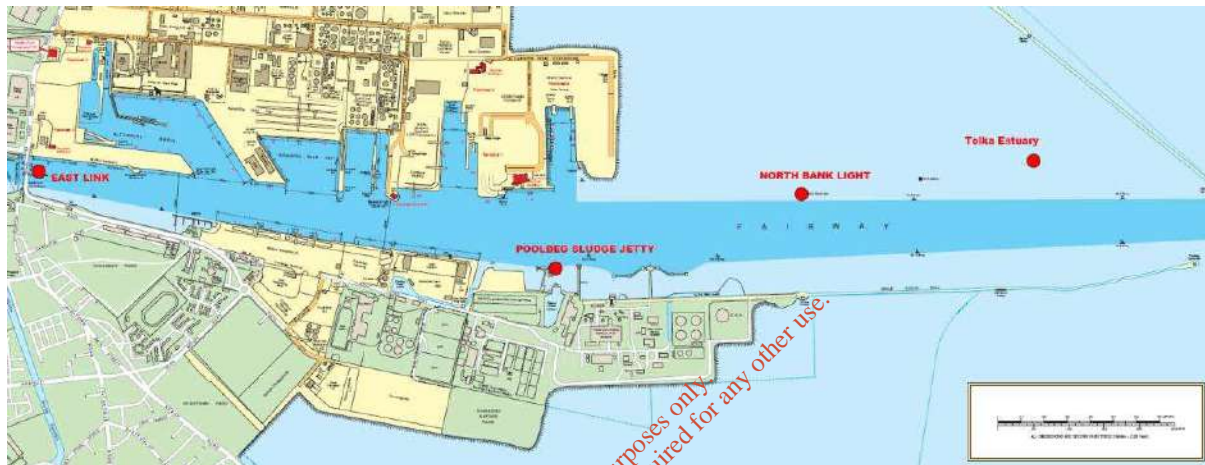
Turbidity is being measured continuously at four monitoring locations within the inner Liffey channel. The monitoring locations are at East Link Bridge, Poolbeg Jetty, North Bank Light and Tolka Estuary as presented in Figure 8.1

Figure 8.1 Locations of monitoring stations in the inner Liffey channel, Dublin Port

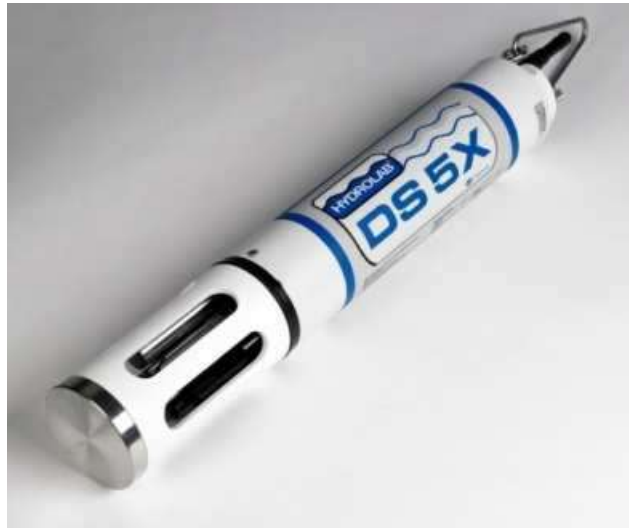
Turbidity is measured continuously as Nephelometric Turbidity Units (NTU) during each loading campaign using Hydrolab DS5X Self-Cleaning turbidity sensors at all four locations. Sensors have a range of 0 - 3000 NTU, with a resolution of 0.1 NTU from 0 - 400 NTU and 1 NTU over 400 NTU. Accuracy is $\pm 1\%$ up to 100 NTU. Turbidity measurements are reported every 15 minutes. Routine cleaning and calibration of sondes is carried out at approximately monthly intervals. Calibration visits during 2017 are listed in Table 8.1.

Hydrolab DS5X Self-Cleaning turbidity sonde

Turbidity is measured at each site at 15 minute intervals. Ambient physico-chemical conditions may vary significantly and rapidly in estuarine environments such as in Dublin Port and its approach channels. Amongst other factors tidal and riverine currents, effluent discharges, surface water runoff and vessel movements exert large influences on the turbidity and suspended solids status of local waters.

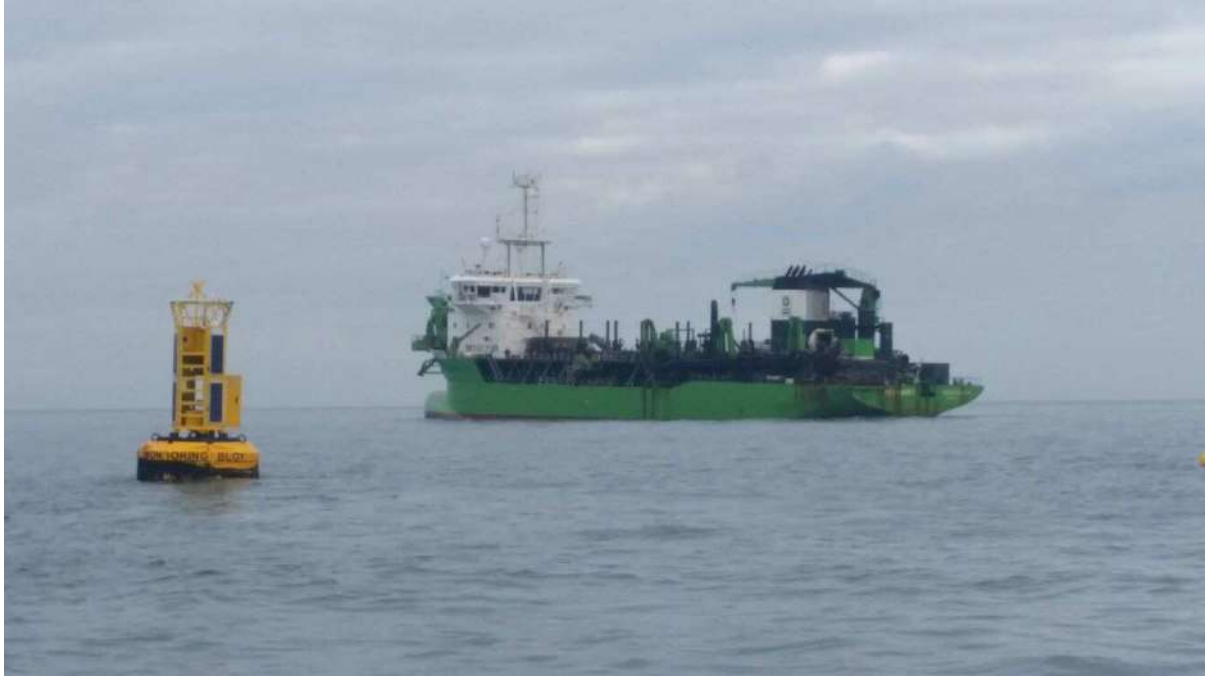
TSHD Reynaert at the Dublin Bay dump site with CoastEye monitoring buoy in the foreground

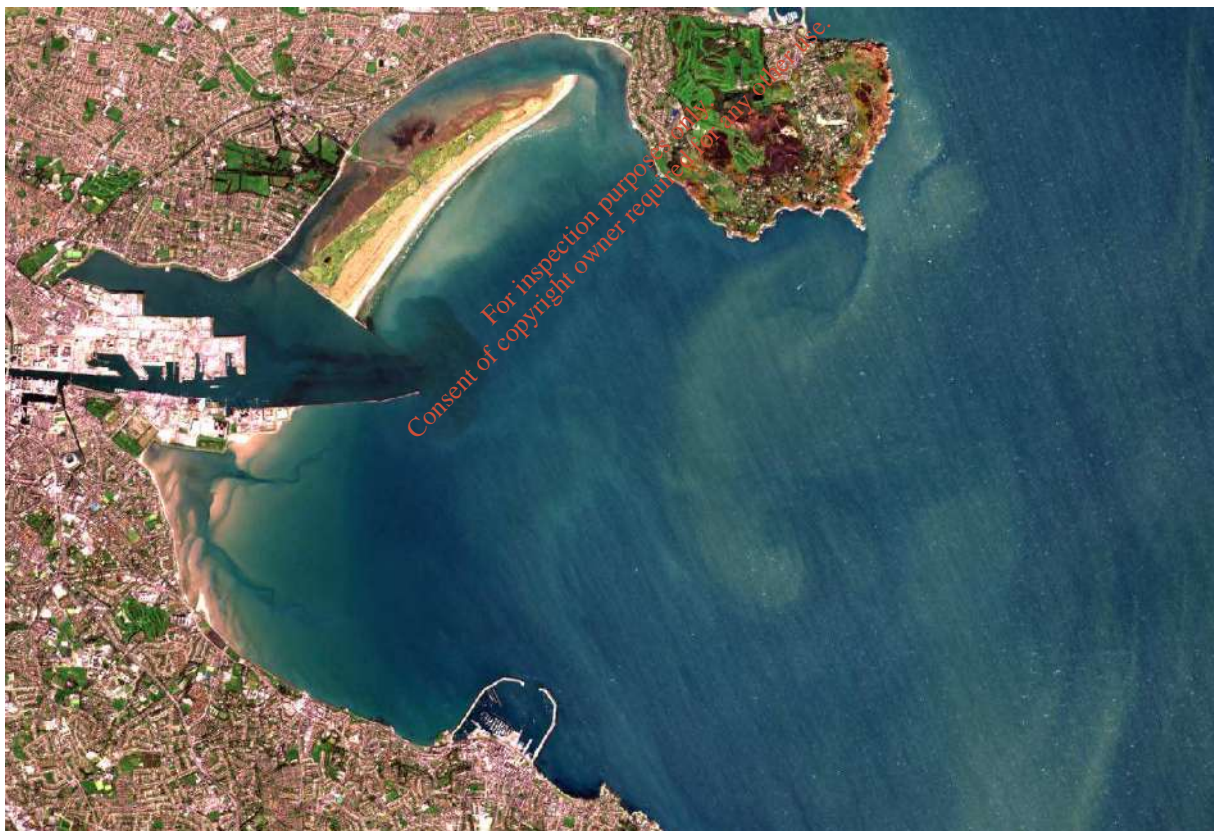
Figure 8.15 Satellite image of Dublin Bay recorded by Sentinel 2, 8th April 2017 at 11:33am

The results show the spring – neap – spring tidal cycles and wave action during storm events are the dominant causes of the natural variations in turbidity which exist in Dublin Bay. Further evidence is provided by satellite imagery (ESA Sentinel 2 & 3) for Dublin Bay as illustrated in Figures 8.15 and 8.16. These images, taken prior to any dredging activity, clearly show natural elevated suspended solids levels particularly off Howth Head and Dun Laoghaire Harbour. The satellite images are only available for cloud free days so do not illustrate the larger suspended solids variations expected during storm events.

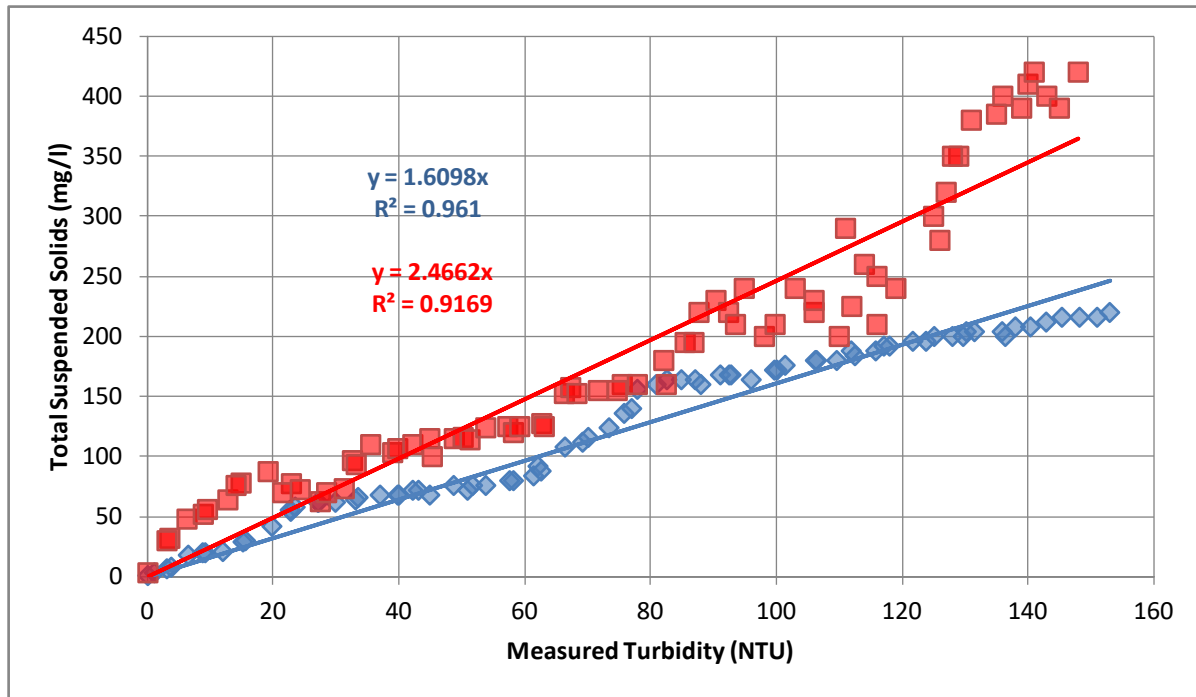
The turbidity and TSS measured in water samples are plotted (red series in Figure 8.17 for comparison with the calibration curves derived for the sediments (blue series in Figure 8.17). The relationship between turbidity and TSS is much weaker in these water samples ($r^2 = 0.04$). This is not unexpected since suspended sediment contributing to turbidity in these samples is derived from a disparate range of sources over an extended period. Many of the measured turbidity and TSS values are also at the very low end of the data range. However, it is noteworthy that the slope of both curves is similar at 2.1 and 2.5 for the water samples and the sediment suspensions respectively. The slope of the curve for the water samples is intermediary between calibration curves for silt and fine sand suspensions.

Figure 8.17 Plots of TSS versus Turbidity for suspensions of river bed silt sediment (red) and approach channel fine sand sediment (blue). Equations and r^2 values for each series are shown in corresponding colours.

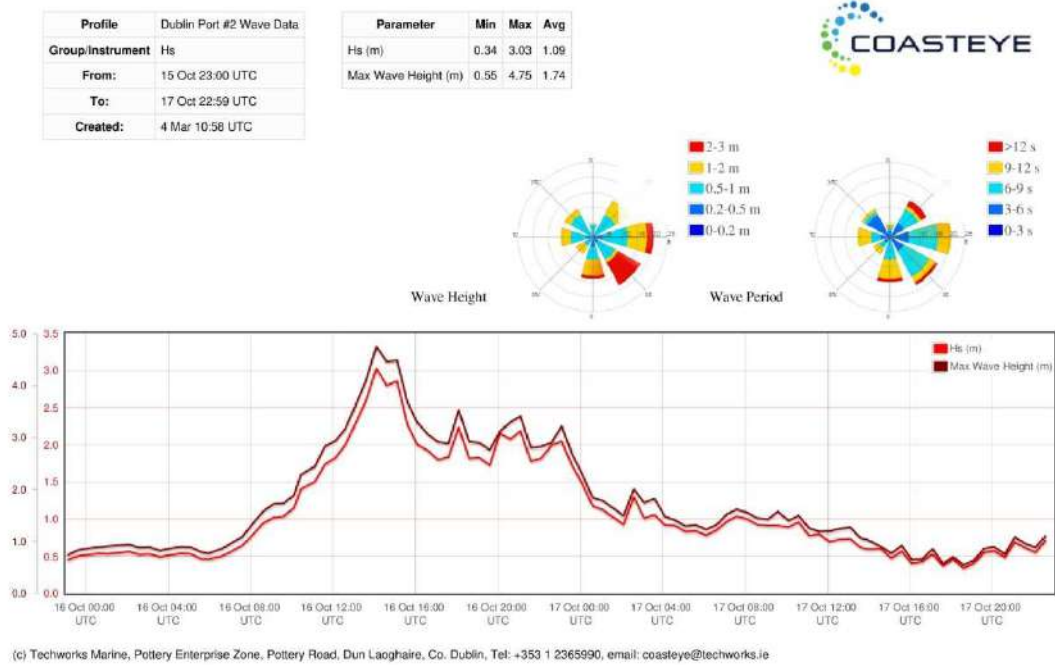
Peak wave periods were in the range 8.5 – 10.5 seconds.

Figure 9.2 Wave conditions recorded during Storm Ophelia on 16th October 2017

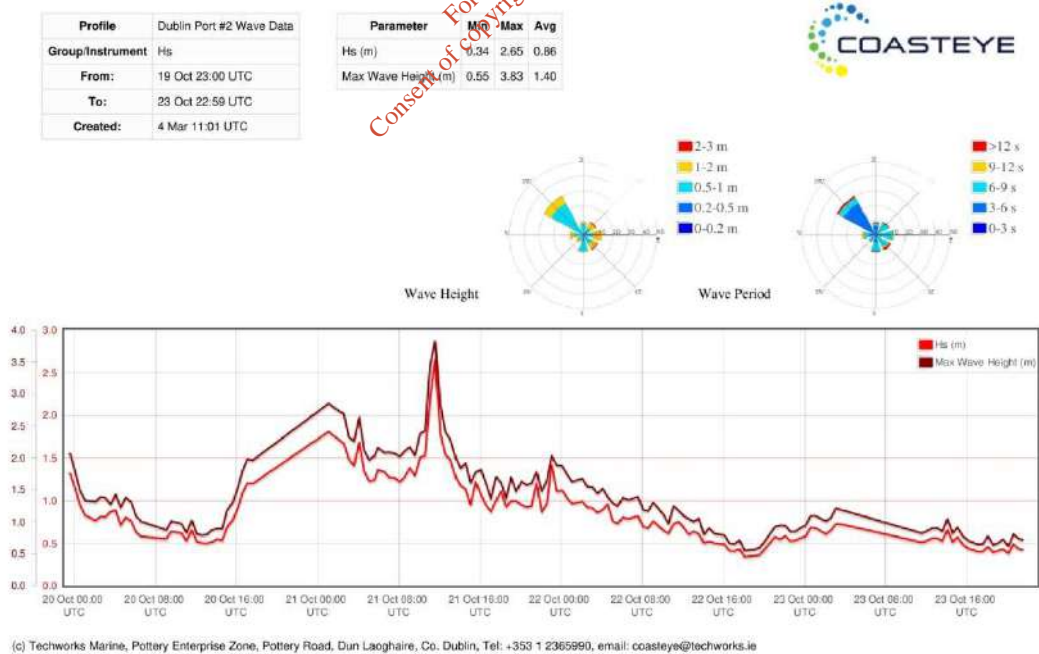
Figure 9.3 Wave conditions recorded during Storm Brian on 21st October 2017

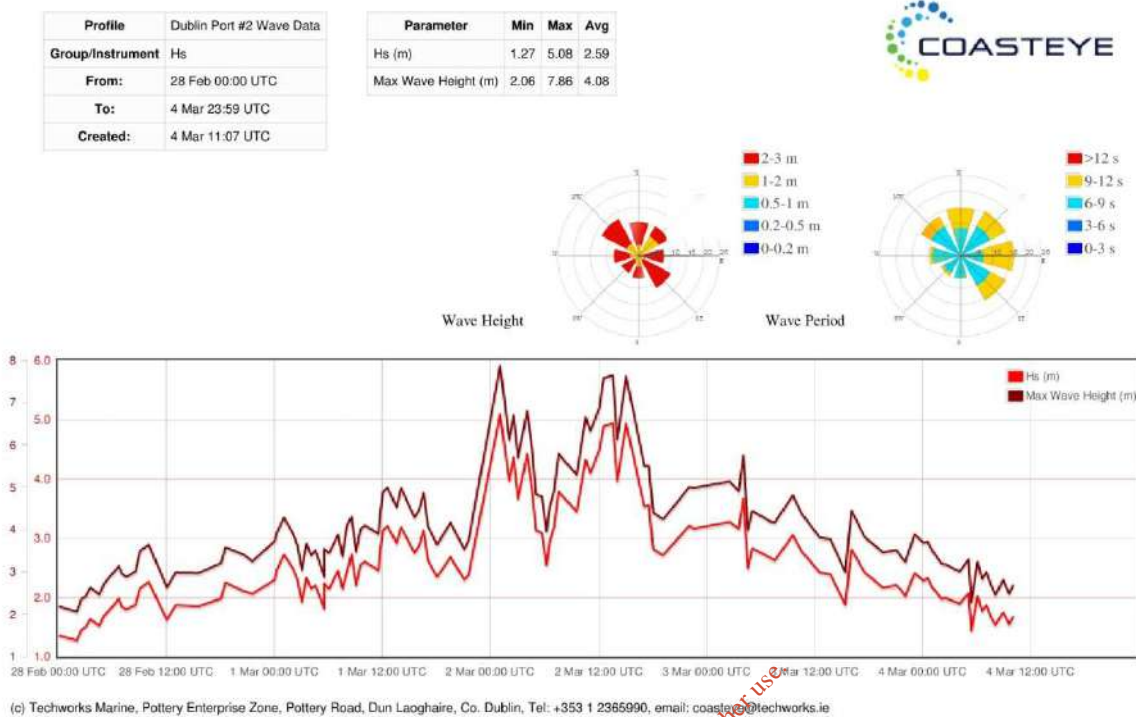
Figure 9.4 Wave conditions recorded during Storm Emma on 2nd March 2018

The largest significant wave height recorded between September 2017 and March 2018 was 5.08m during Storm Emma on 2nd March 2018. This storm approached Ireland from the south and combined with strong easterly winds from mainland Europe (the beast from the east) causing blizzard conditions in Dublin. The extreme wave climate recorded is similar both in significant wave height and wave period to that used in the environmental appraisals within the NIS (5.4m significant wave height, 10.4 second peak wave period).

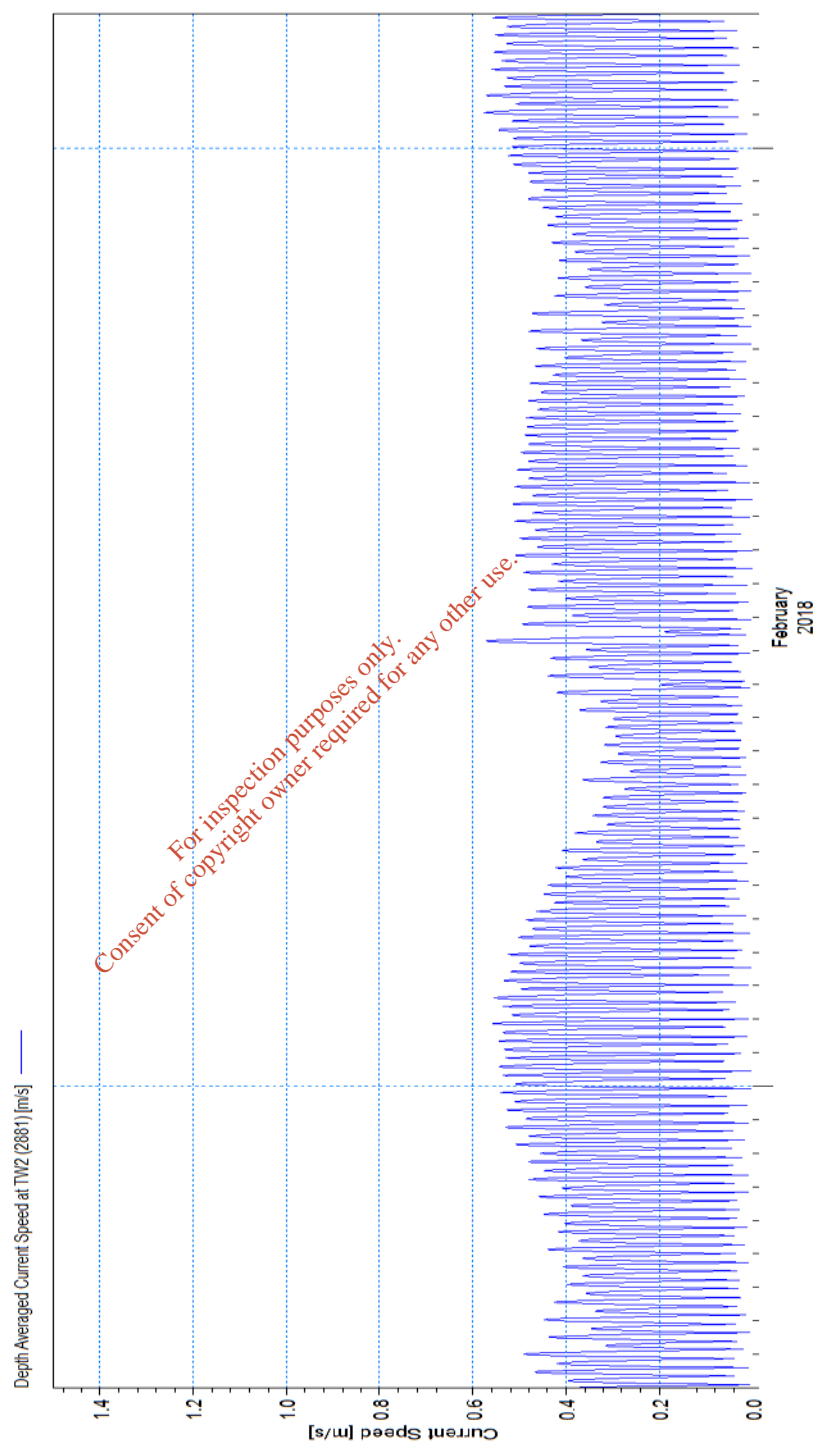
A Mike 21 Hydro Dynamic (HD) model, developed by DHI was used to simulate the existing tidal regime in Dublin Bay, including the fairway, approach channel and berths of Dublin Port. A tidal Atlas of the model results are presented in Appendix 9. The model of the existing tidal regime was calibrated using tidal height data and current data from deployed ADCP current meters in Dublin Bay to ensure that the model results were representative of actual conditions.

Figure 9.6 Depth averaged tidal currents predicted by the Mike 21 Hydro Dynamic (HD) model, coupled to RPS's storm surge forecast model (23rd January to 4th March 2018)

In conclusion, the results of the hydrographic monitoring (waves and tidal currents) are consistent with the predicted results of the computer models and validate the hydrodynamic and wave climate model presented in Appendix C: Coastal Processes Modelling to the Natura Impact Statement (NIS) submitted as part of the Dumping at Sea Permit application.
